Seven-Fatality Fire at Remote Wilderness Lodge Grand Marais, Minnesota

Seven-Fatality Fire at Remote Wilderness Lodge Grand Marais, Minnesota (July 12, 1991)

Report by: James W. David

**This is Report 055 of the Major Fires Investigation Project conducted
by TriData Corporation under contract EMW-90-C-3338 to the United
States Fire Administration, Federal Emergency Management Agency.**

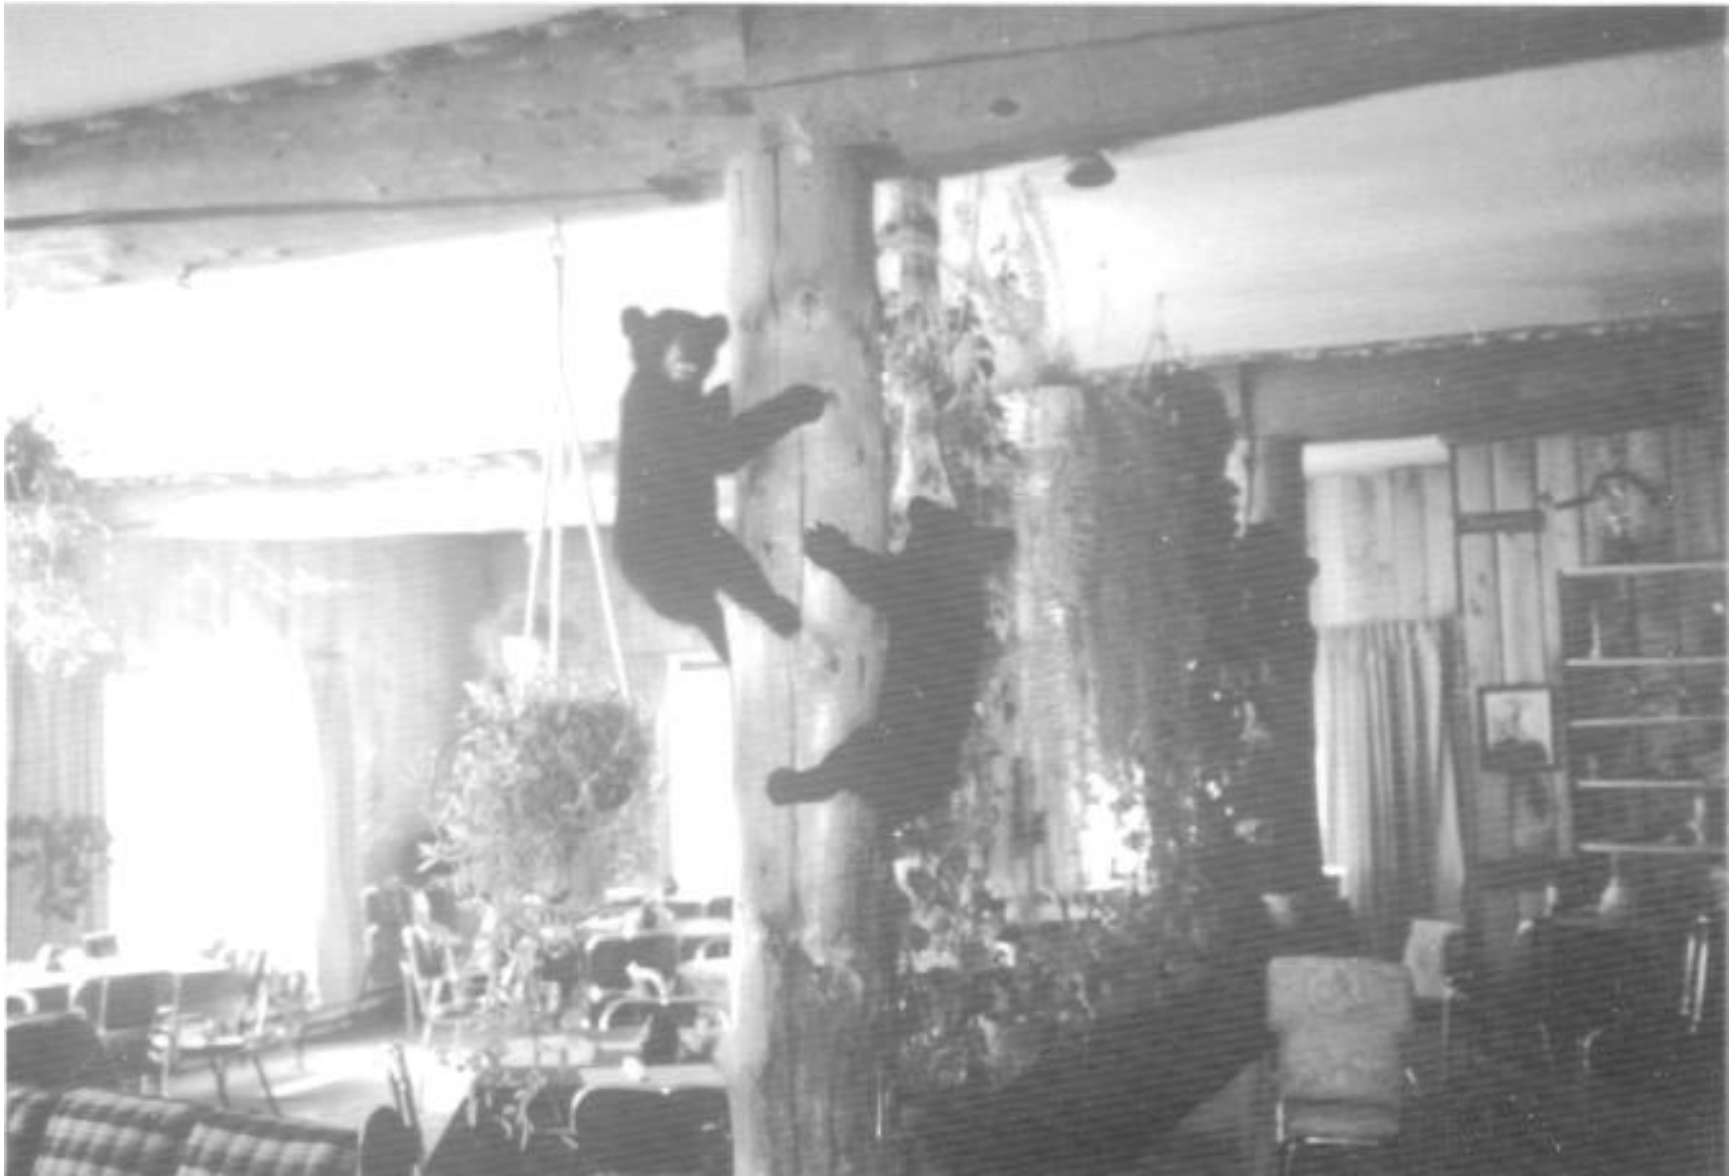
It was stated the ceiling construction on the first floor was sheet rock with exposed beams. However, there were indications from witnesses and photos that the sheet rock had large gaps where it met at the beams. This allowed fire to travel to the floor construction above and probably contributed significantly to the fire spread.

Dining room and lounge area on first floor. Note ceiling separations at log beams.

5. Decorative elements, such as the exposed ceiling beams in this case, require that special efforts be made to insure the fire-resistive integrity of the construction.

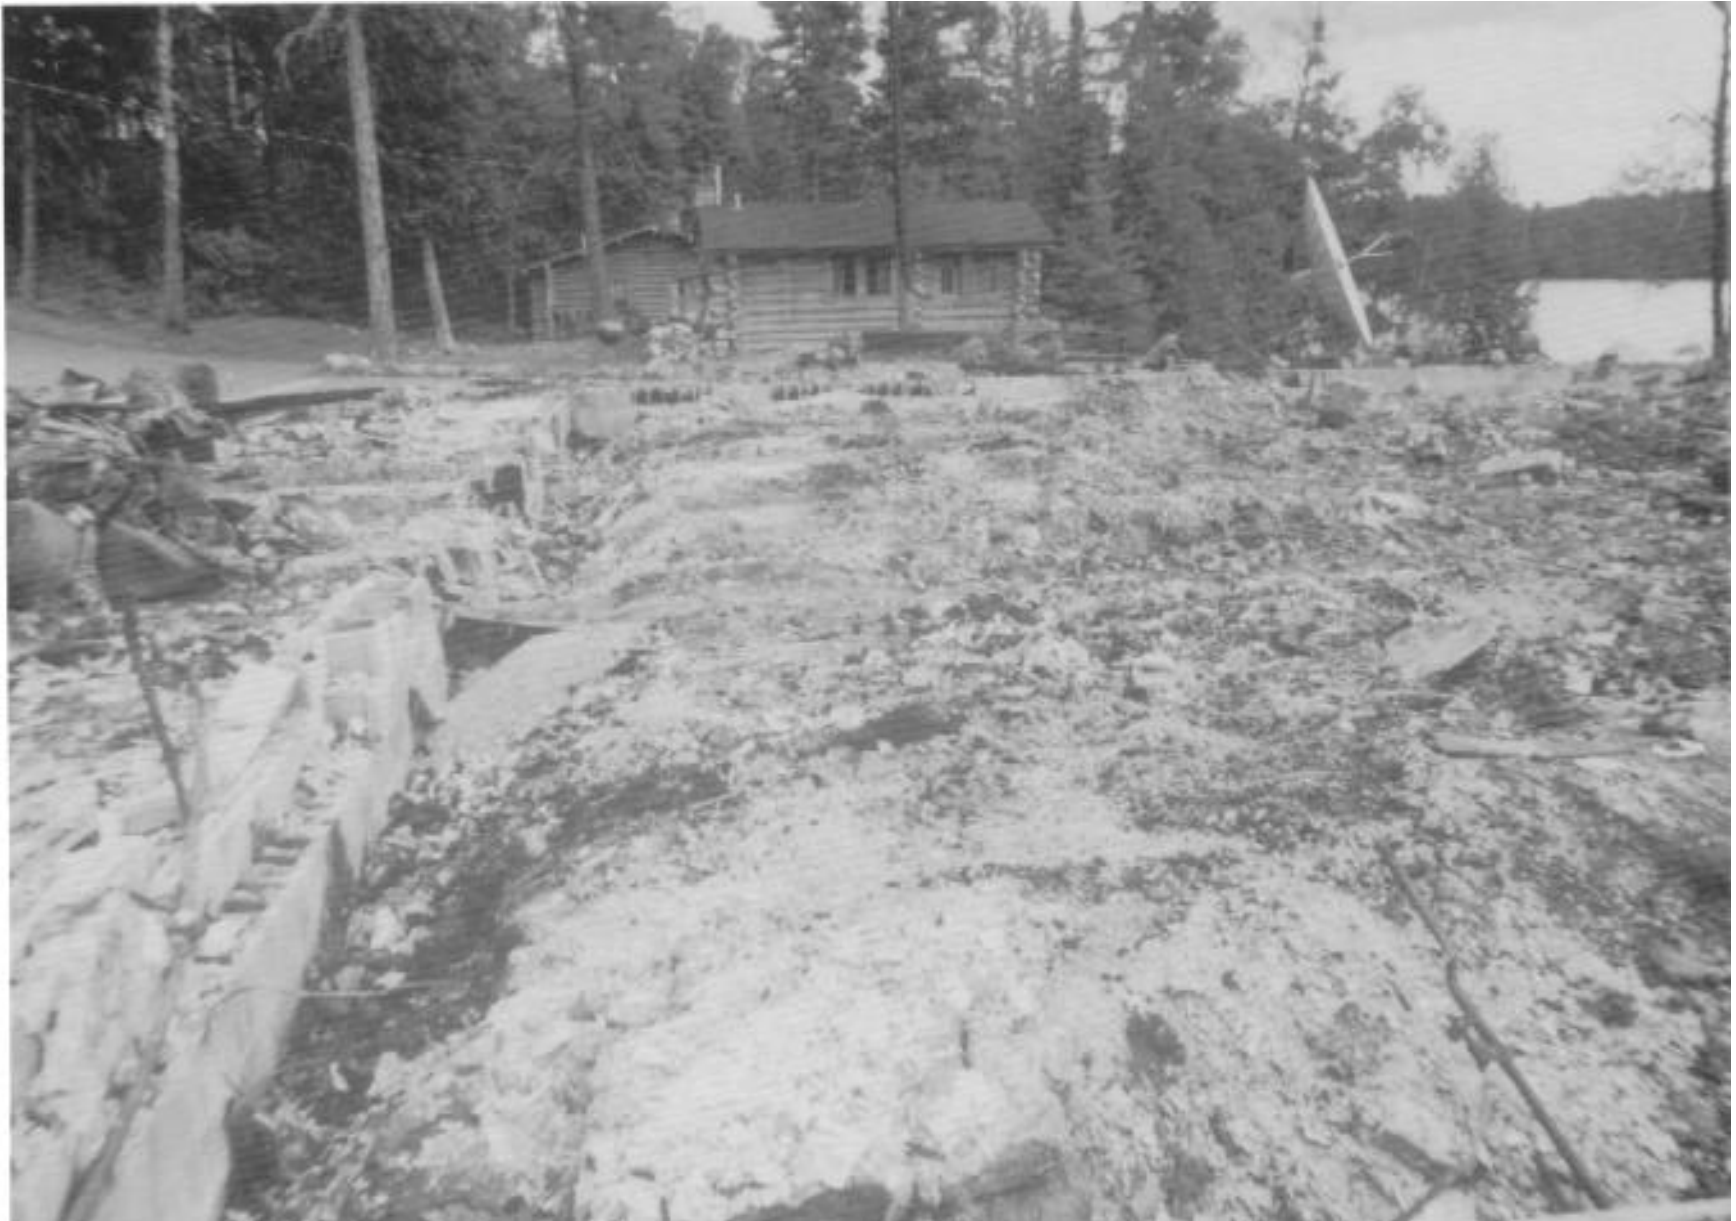
View along north foundation wall shows total destruction of lodge by the fire.

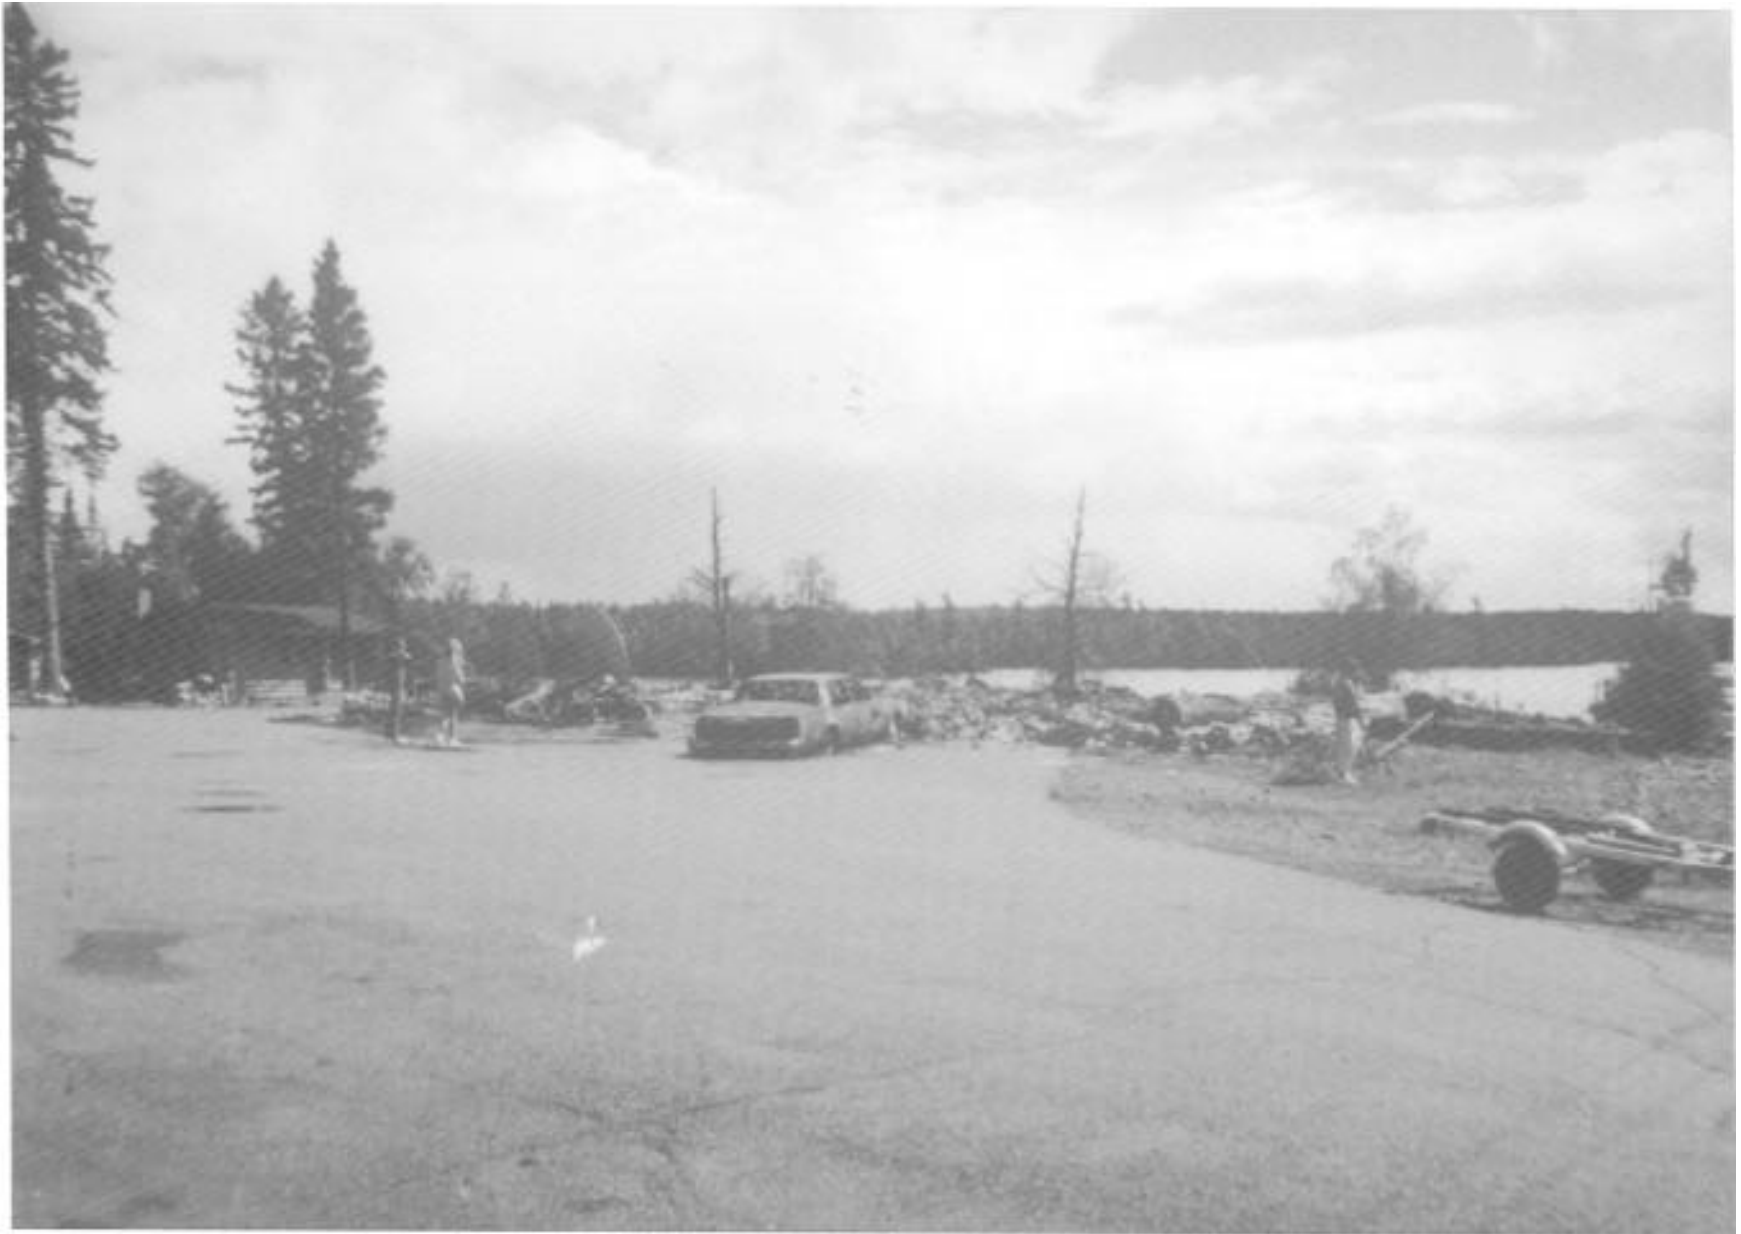
Remains of Lodge from west drive, facing lake.

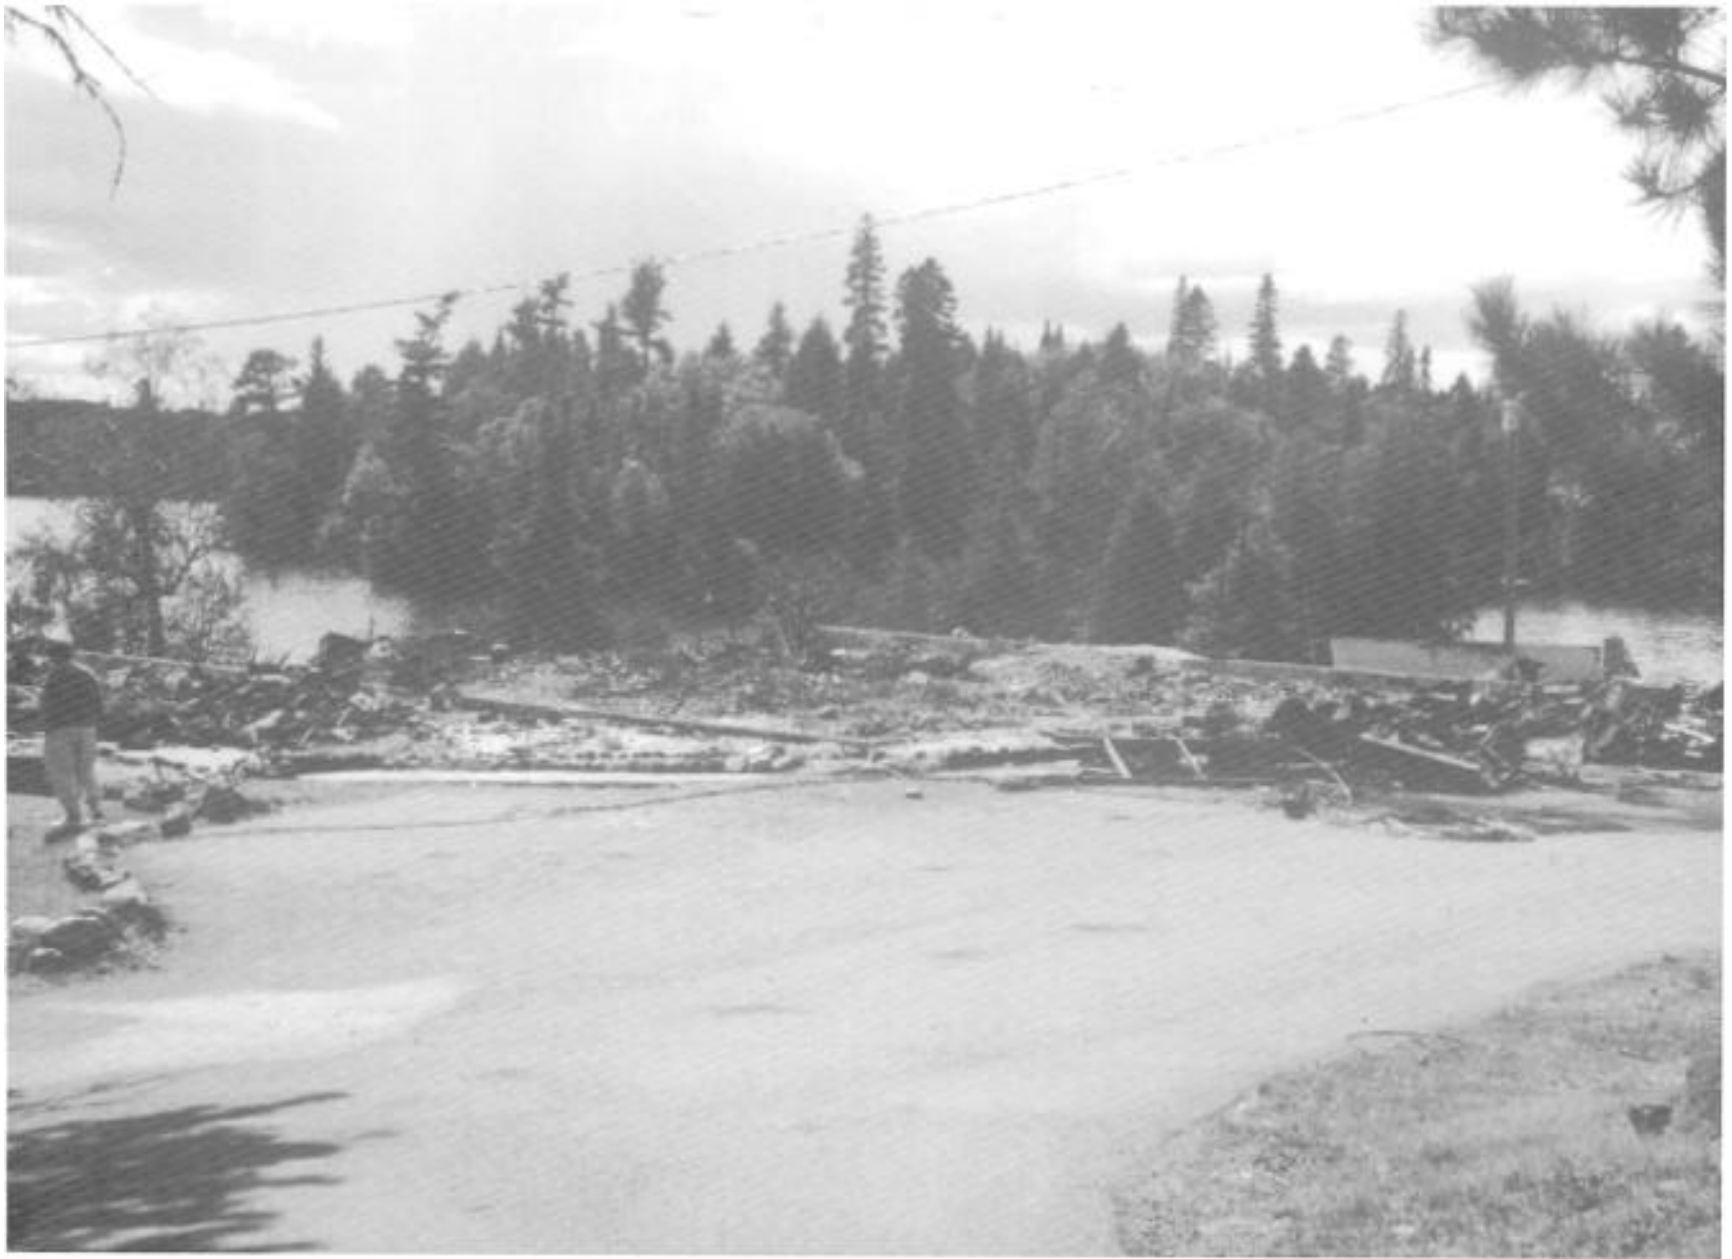
Remains of Windigo Lodge from east drive, facing lake.

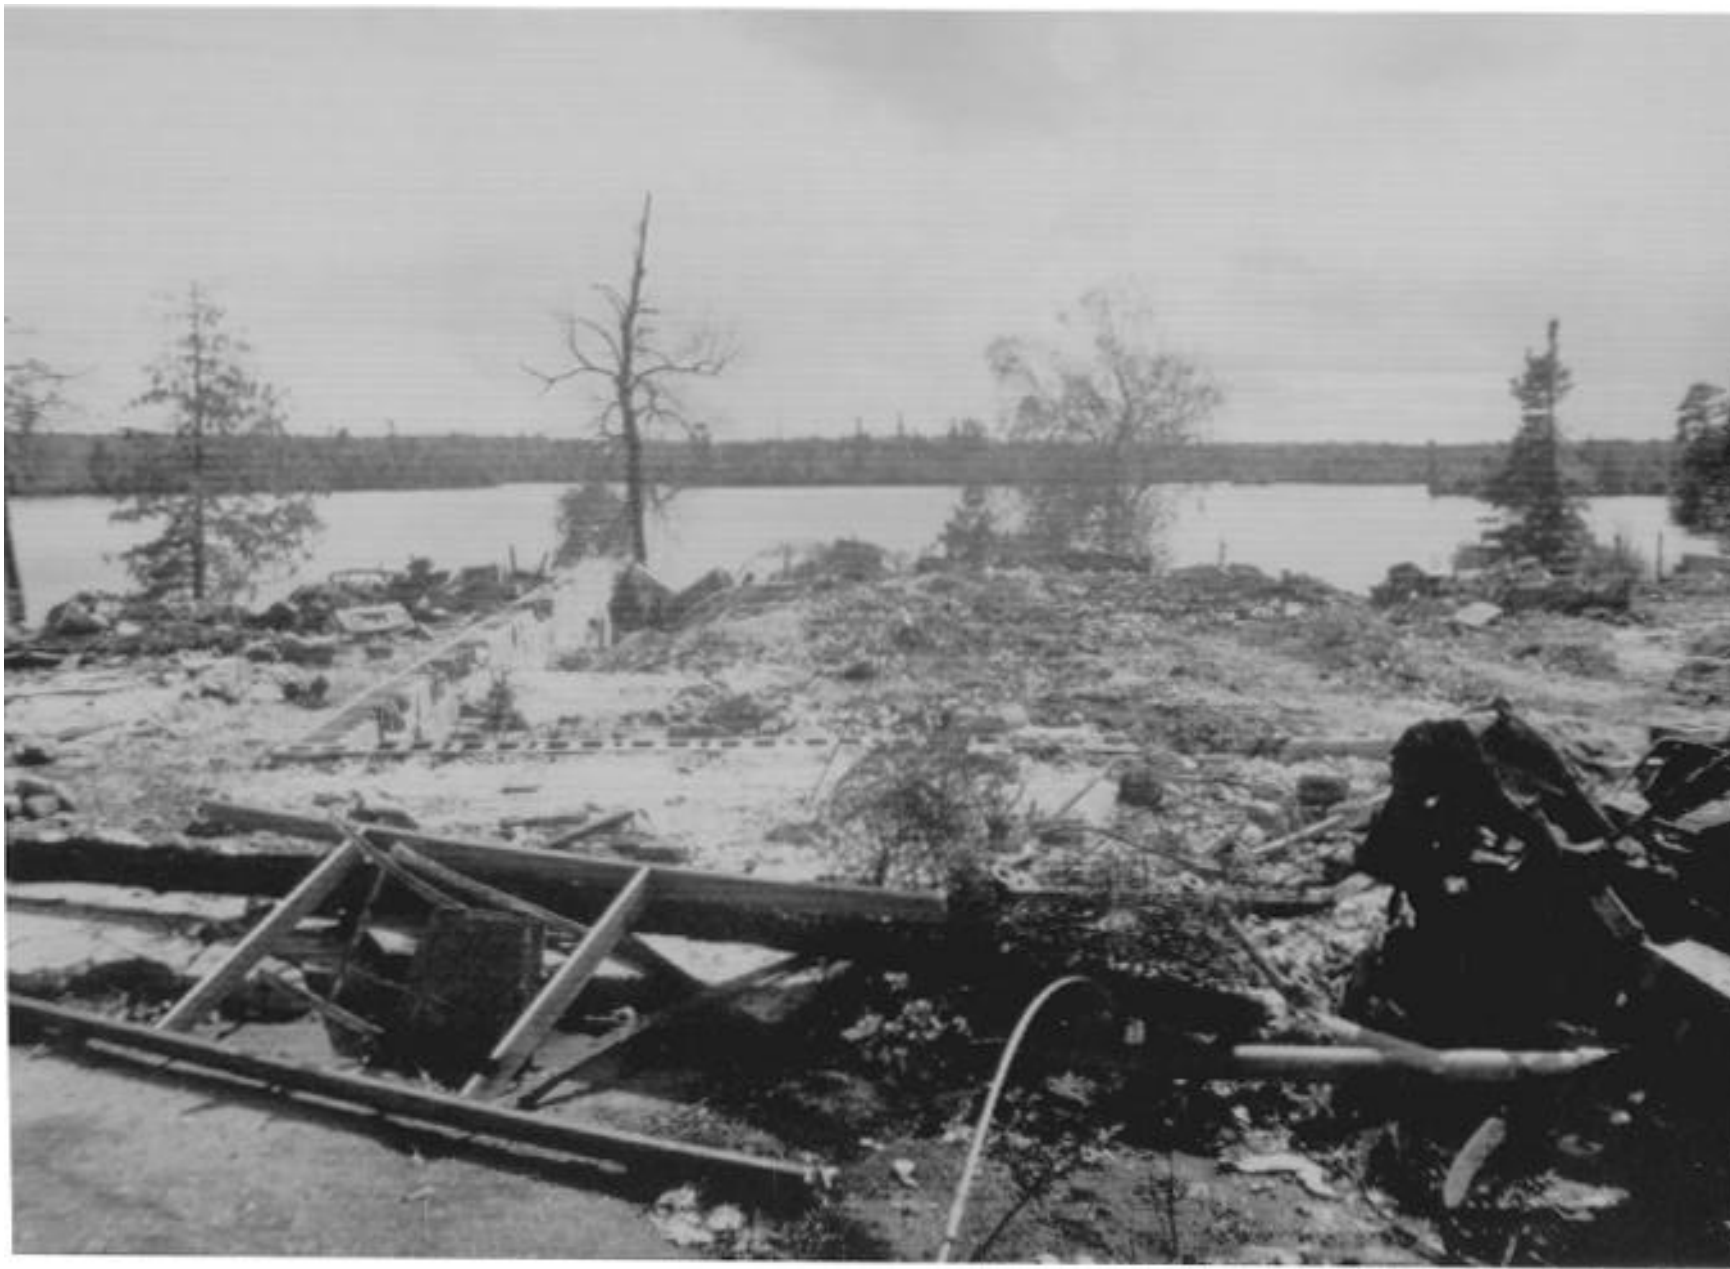
Entire structure was consumed by fire; east and north foundation walls shown here.

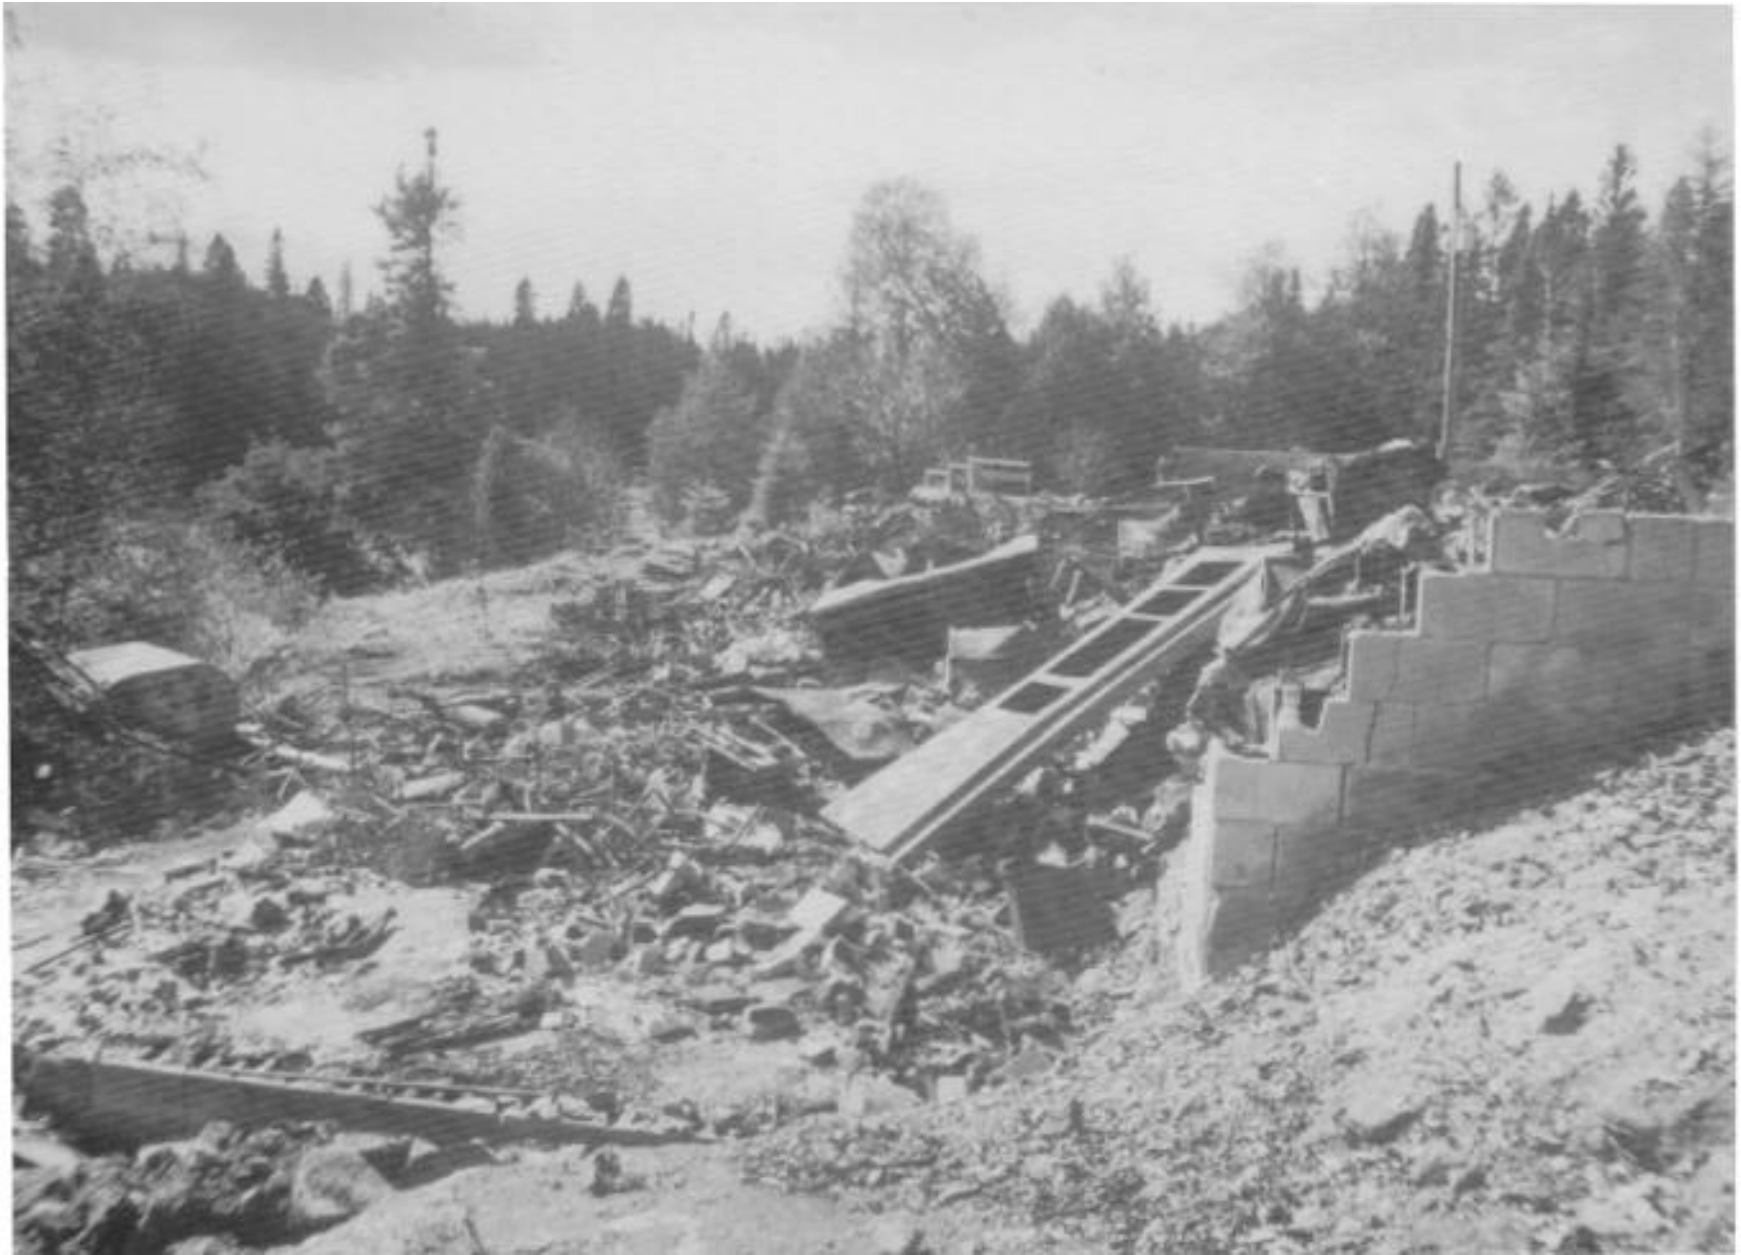
East foundation wall and basement walkout to lake (off photo to left);
basement wood frame construction consumed by fire.

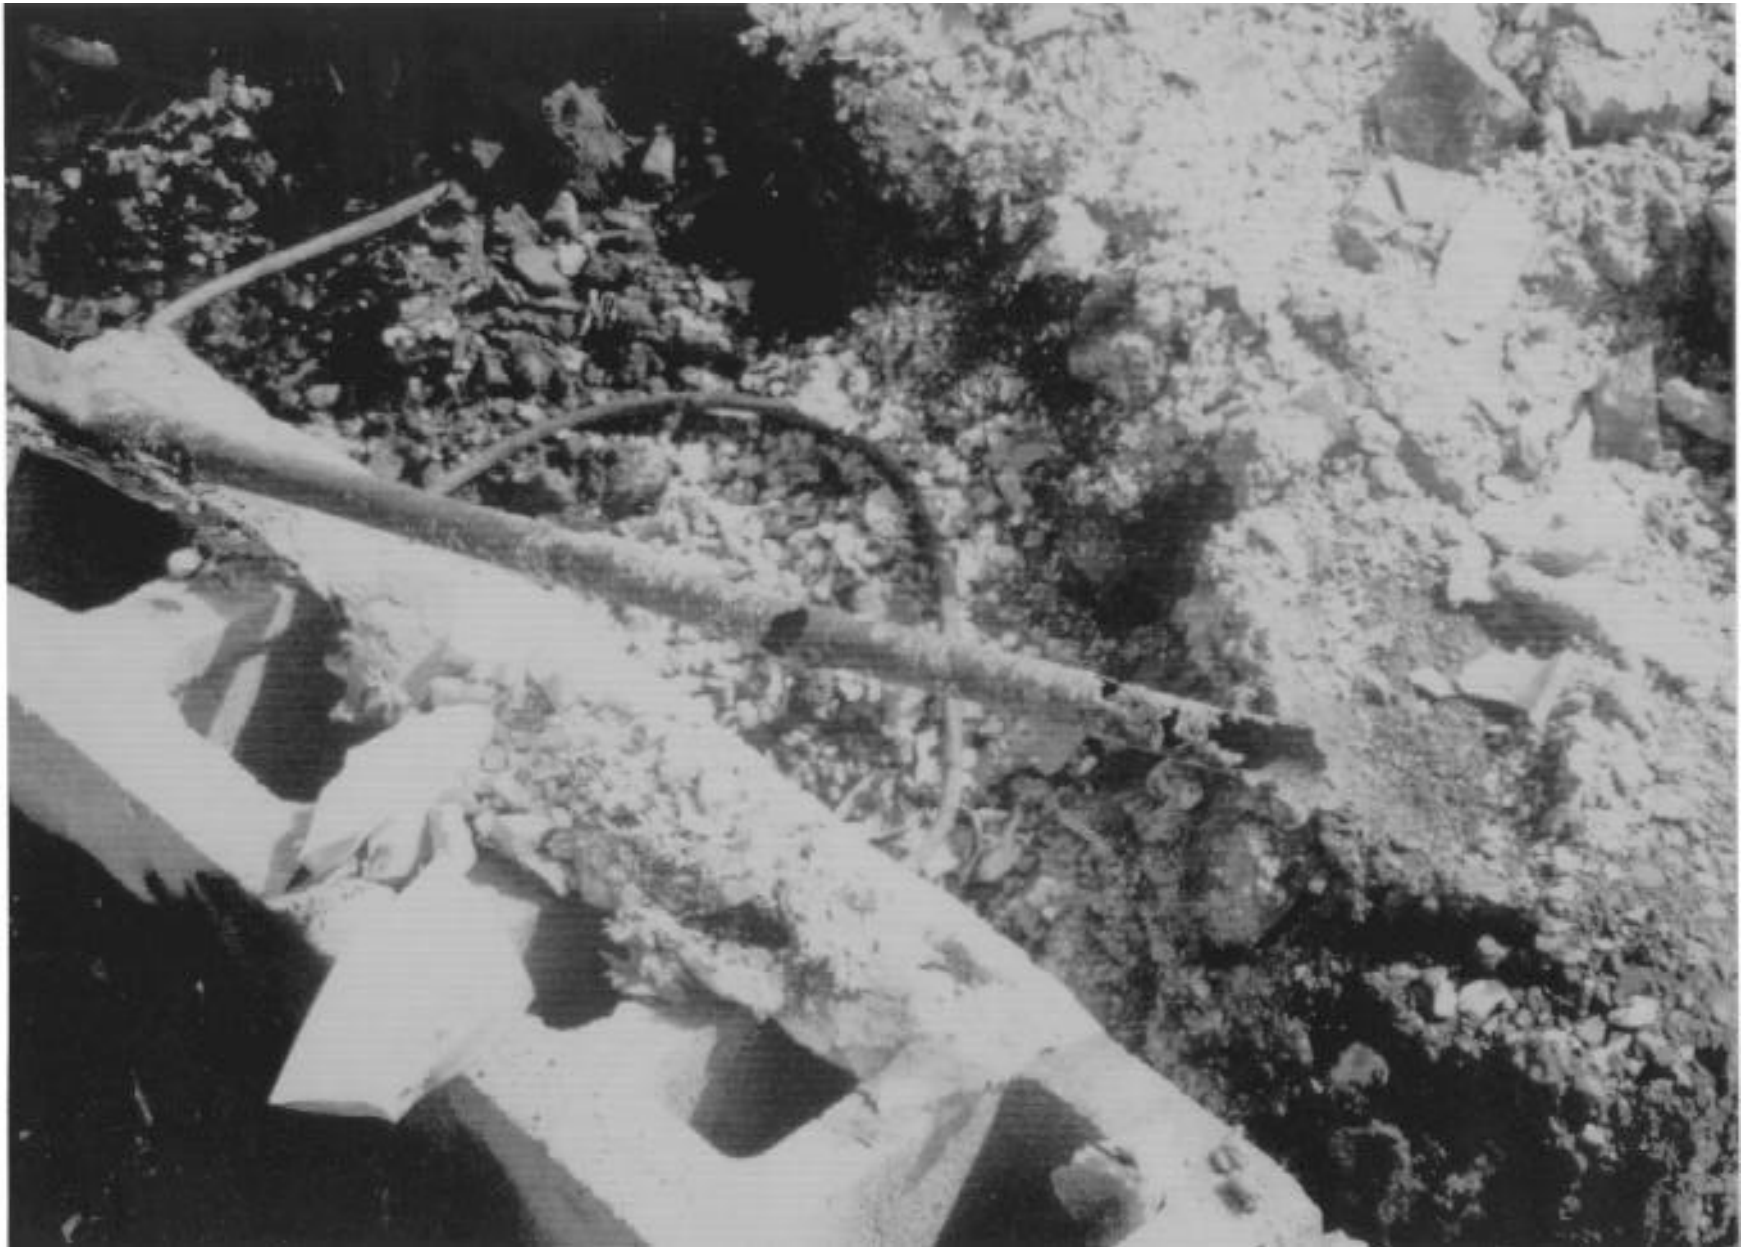
Damage to 3/4-inch copper water pipe from intense heat of the fire.
